# Impact of Hail

## on Rubber & Plastic Roofing Systems

by Ric Vitiello

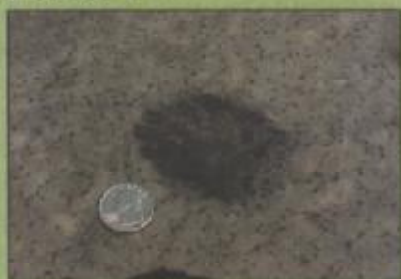
**Photo 1**

In the case of the impact shown in Photo 1, the size of the hailstone

*Hail impact on EPDM membrane roof produced no damage.*

appears to have been approximately 51 mm (2 in.) in diameter. Photo 2 shows the hailstones dented the isocyanurate insulation below the roof membrane. Although the hail created a cavity in the insulation approximately 25-mm (1-in.) deep and as large as the surface clean spot, no damage to the EPDM roof membrane was indicated. It simply repelled the hail and returned to its original shape.

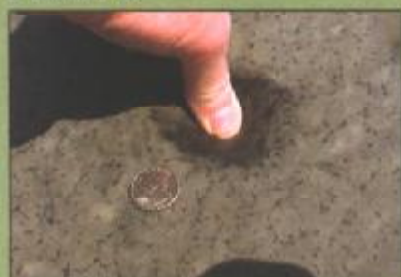
**Photo 2**

*Indentation in insulation below membrane.*

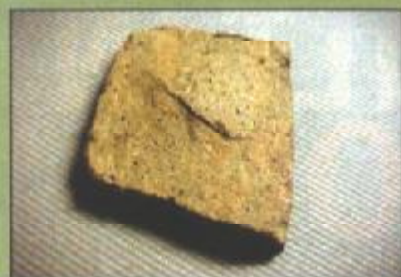
**Photo 3**

*EPDM test sample. 13-mm (0.5-in.) re-cover board is fractured.*

A storm producing dense hailstones the size of baseballs recently passed over the building, leaving in its wake large impressions in the surface and a fracture in the re-cover board (Photo 3). However, the EPDM membrane over the fractured board showed no signs of damage (Photo 4). Other possible locations for damage were explored, such as where the membrane may have been compressed between insulation board fasteners and other metal components, or the embedded drip edge, but no damage was found to the roof covering membrane.

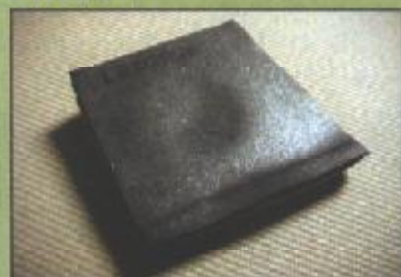
**Photo 4**

*EPDM test sample. Although 13-mm (0.5-in.) re-cover board is fractured, no damage was done to the EPDM membrane.*

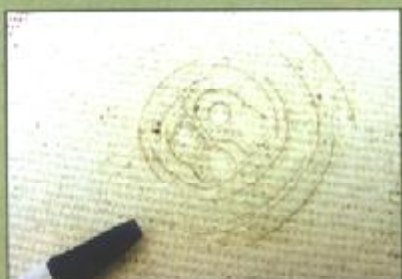
**Photo 6**

A multi-level aircraft engine manufacturing facility had sections of its roof replaced and/or re-covered over a period of approximately 17 years. All of the roofs studied were of PVC material and had recently been hit by large hailstones. Three sections of the roof—seven, 12, and over 15 years old, respectively—were covered by reinforced membrane over plastic foam insulation. All these sections were severely damaged by the hailstones, determined to have been as large as 51 mm (2 in.) in diameter, although many of the fractures indicated impact by smaller hailstones (25-mm [1-in.] in diameter (See Photos 6 and 7).

*Hail impact fracture to reinforced PVC membrane.*

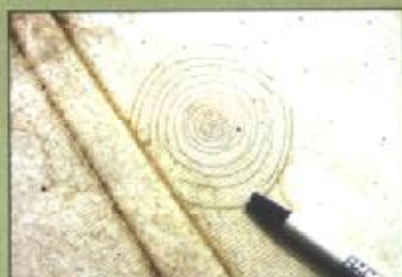
**Photo 7**

*Hail impact fracture to reinforced PVC membrane.*

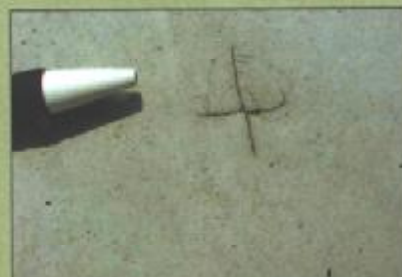
**Photo 8**

*(Small) hail impact fracture to reinforced PVC membrane.*

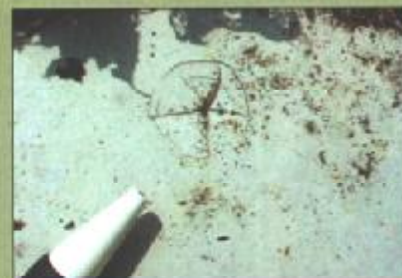
**Photo 9**

*(Small) hail impact fracture to reinforced PVC membrane.*

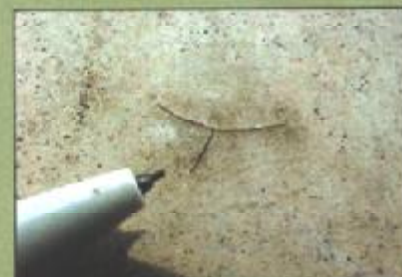
**Photo 10**

*(Small) hail impact fracture to reinforced PVC membrane.*

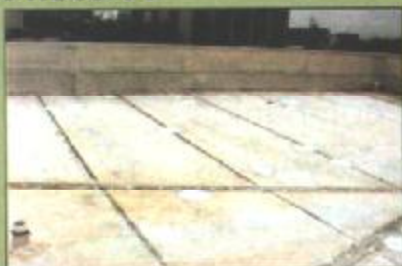
## Photo 11

The roof on this surgical office building was installed within the last five years. Since the passing of a hailstorm two years ago, roof leaks have repeatedly occurred because of a membrane fracture. Photo 11 shows patched spot repairs completed by a number of competent contractors, but none of them have been able to prevent the reoccurrence of leaks. Although study revealed previous repairs were completed properly, stresses within the membrane due to thermal cycling were causing additional fractures to open.

*Overview of previous repairs performed after the hail storm.*

The fractures causing immediate leaks had been repaired, but the hailstorm had also caused fractures that did not extend completely through both laminates of the membrane. Over time, the repeated expansion and contraction of the membrane caused the fractures to tear through the bottom laminate below the scrim sheet, which caused additional leaks to appear. Photos 12 and 13 show the fractured upper laminate of a membrane sample and its underside, with a fracture that has not completely split to match the top (although there is some leakage). Since the roof could no longer be considered dependable, particularly since it is covering a surgical facility, replacement was recommended.

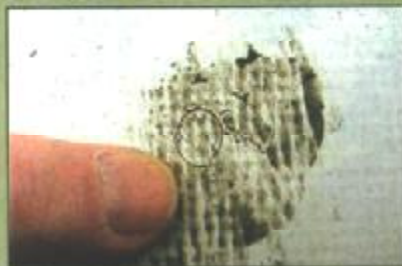
## Photo 12

*Test sample. Hail impact fracture to reinforced PVC membrane.*

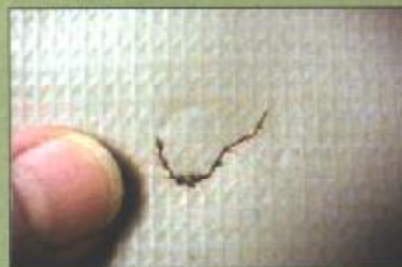
## Photo 13

*Test sample. Underside of membrane indicates complete fracture allowing leaks.*
