# A PROPOSAL FOR UNIFORMLY ASSESSING HAIL DAMAGE TO ROOFS

BY LYLE D. HOGAN, FRCI, PE

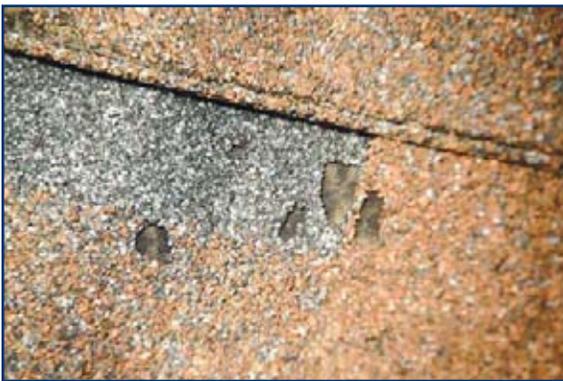
*Figure 1 – Hailstone pockmarking is the loss of ceramic granules and the asphalt top coating. Where this has occurred, the shingle has been compromised, especially if the glass reinforcement is exposed.*

It is generally recognized that pockmarking involving loss of both ceramic granules and the asphalt top coating constitutes damage by falling hailstones (*Figure 1*). Where this characteristic signature has occurred, the shingle has been compromised, especially if the glass reinforcement is exposed. Inspection should then focus on how many "hits" per square are evident across the roof. That is, a square of roofing is demarcated, and individual hits are counted within that area. Several such areas should be quantified to

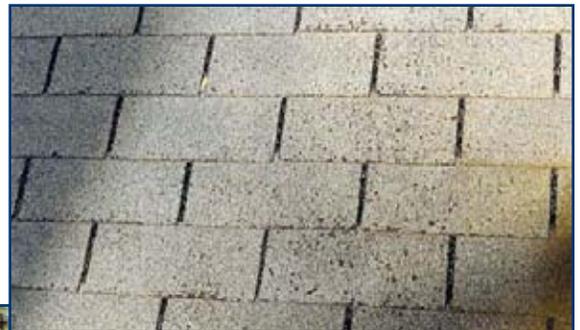
Hail damage should not be confused with heat blisters, observed on occasion with lightweight, "utility-grade" shingles. This condition, also known as "rash blistering," is particularly likely with substandard attic ventilation (*Figure 2*). The small blisters can rupture under even very light contact, leaving the appearance of small pockmarks. This occurrence is often non-uni-

*Figure 2 – "Rash blistering" is particularly likely when substandard attic ventilation is afforded. The tiny blisters can rupture under even very light contact, leaving the appearance of small pockmarks.*

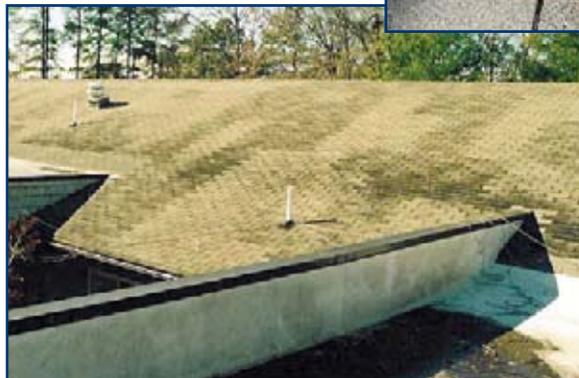
*Figure 3 – Lot-to-lot variation in a shingle product.*

form across a roof, severe in areas and moderate in others (Figure 3) because of lot-to-lot variation in the shingle product or differences in ventilation effectiveness. However, rash blistering and weathering variations are completely unrelated to unusual weather events, as both can occur in the complete absence of hail.

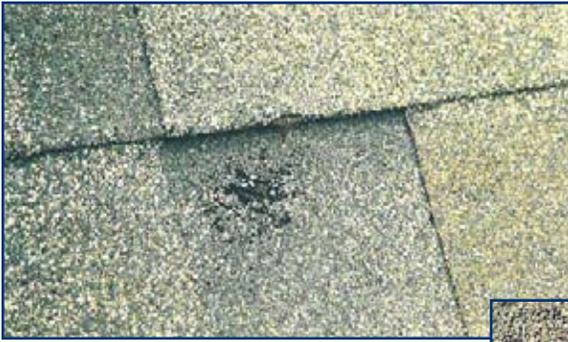
*Figure 4 – “Bruising” of the protective granules but no loss of the coating asphalt. Surface temperature at the time of hail has considerable influence on damage susceptibility.*

There can be a condition known as “bruising” (Figure 4) where there is removal of the protective granules but no loss of the coating asphalt. This condition may result from particles having less density than hard-frozen hailstones, a matter discussed further below. Prevailing surface temperature at the time of hail has considerable influence on actual susceptibility of a roof to sustain damage. None of these surface appearances should be confused with “scuffing,” which can stem from several sources, including periodic trafficking.

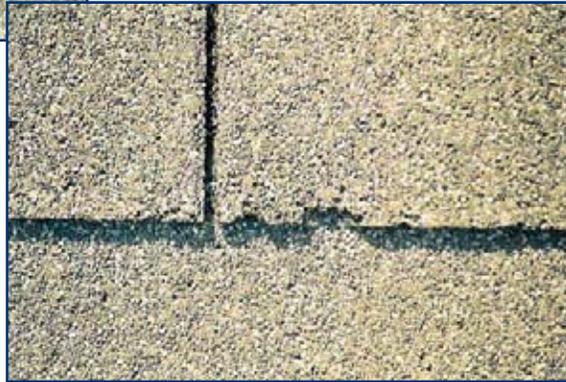
Shingles that overhang rake lines can be a good indicator of hail exposure. Absence of impact damage along these vulnerable locations is indicative of moderate hail intensity, small particle diameter, or both. But to complicate the matter, there can also be chipping of shingles along edges only (Figure 5). More than once, we have recorded hail hits that produced chipped edges but did not generate ordinary pockmarks anywhere. Water-shedding effectiveness was not compromised (because of the two-ply construction and headlap of properly installed shingles), but there was, nonetheless, some reduction of expected service life. This office associates such behavior with products that also

*Figure 5 – Chipping of shingles edges (only) with no evidence whatsoever of ordinary pockmarking.*

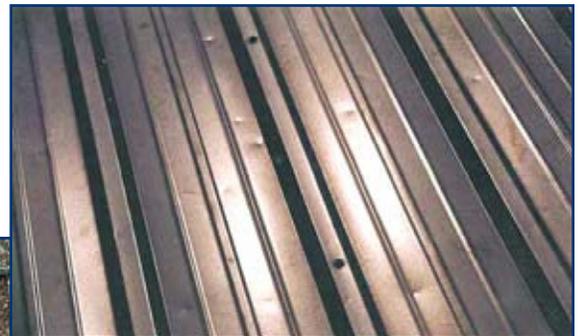
prompt consideration of damage sustained. Soft metals such as copper, lead, and light-gauge galvanized steel are likely to have indentations confirming hail exposure. Curiously, 26-gauge galvanized (Figure 7), although in vogue in several locales, is siding material, inappropriate for roof construction. Such a covering is unrated and unlisted with loss prevention agencies and approval guides. The user who specifies or accepts this form of covering may expect surface indentations from even minor hail events – that is, assuming the product can even be installed without crimping or creasing. The property insurance carrier who underwrites such construction can expect trouble.

*Figure 7 (above) – 26-gauge galvanized, although in vogue in several locales, is siding material, inappropriate for roof construction.*

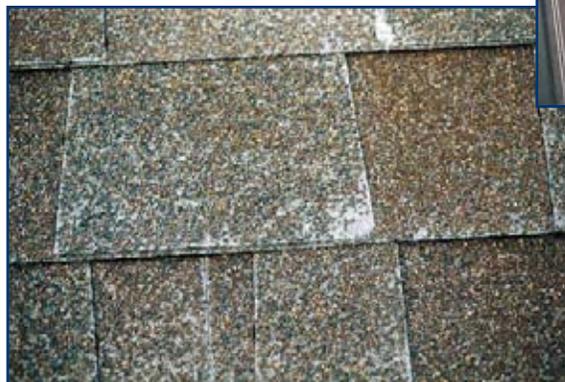
weather in the same pattern, losing granules first along edges (Figure 6).

*Figure 6 – Certain products weather by losing edge granules first. This is a product attribute, completely unrelated to hail activity.*

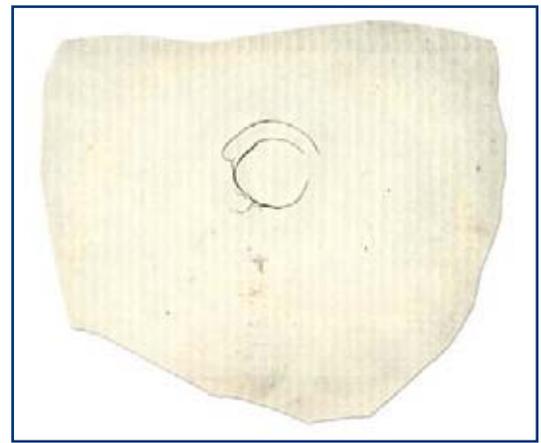
Strong fabric reinforcements were incorporated into later products. As a result, service life vastly improved for many products, but changes in plasticizer chemistry did not always spell success. Hail damage could still result for some membranes, although the reinforcing scrim limited the size and shape of the breach from impact (*Figure 9*). Both images represent fully compromised roofs. However, the latter example, being a modern formulation on a good scrim, should not have occurred and represents a substandard product; it was stiff and boardy (even at moderate temperature) and had clearly lost plasticizer. Although many commercial warranties exclude coverage for hail, quality thermoplastic membranes can withstand fairly aggressive exposure and are tested and rated for the same.

*Figure 9 – Internal reinforcing fabric limits the size and shape of the breach from hail impact.*

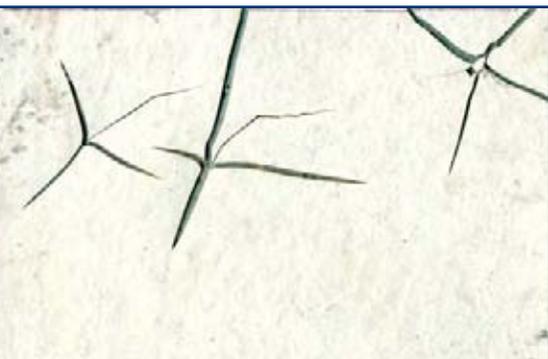
This portion deals principally with PVC and co-polymerized alloys of the same. Some first generation membranes did not have internal reinforcement and routinely experienced loss of chemical plasticizers. Such weathering (rapid in many instances) left these one-ply membranes brittle and vulnerable to rupture under abrupt or concentrated loads. Star-type breaches (*Figure 8*) were a customary response when these products were subjected to hail.

*Figure 8 – Star-type breaches resulted when first-generation PVC membranes were subjected to hail.*

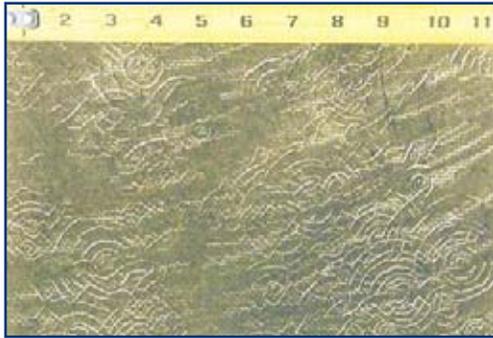
1989 using the same vendor's product. A 1992 hailstorm ravaged the newer portion (*Figure 10*) while the older part was virtually unaffected. This illustrates the continually changing formulation chemistry — some of it good, some not.

*Figure 10 – a hailstorm ravaged this 1989 membrane while the older 1988 phase (same membrane vendor) was virtually unaffected. The loss should not have occurred and represents substandard product.*

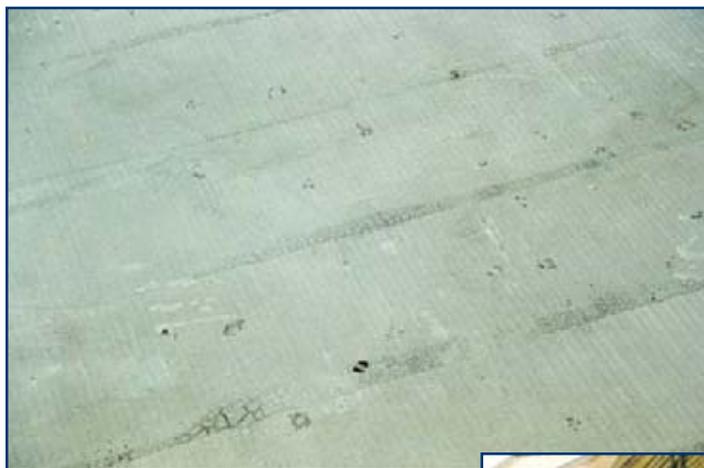
All forms of bituminous roofing should have a UV shield of some type in order to achieve service life expectancy. This protection comes in the form of ceramic granules, gravel surfacing, insulating paver tiles, aluminum coatings, latex paint, high-albedo coatings, clay emulsion, etc. Loss of protective coating leads to rapid degradation of the bitumen. Modern, smooth-surfaced, built-up roofs have fibrous glass felts, providing a sturdy, finished membrane. However, the coating can be compromised by hail exposure, even when the felt plies remain intact (Figure 11). Most such occurrences can be restored by

*Figure 11 – Roof coating can be compromised by hail exposure, even when the felt plies remain intact.*

application of new coating, observing all the appropriate (and recognized) surface preparation parameters.

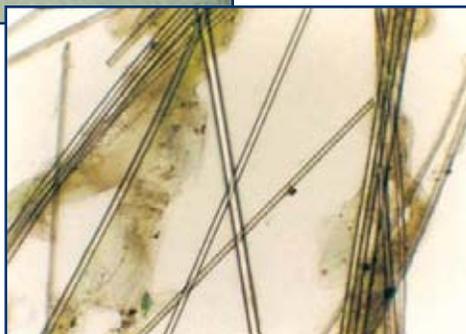
When there is uncertainty about whether felt plies have been damaged, a laboratory procedure can yield good insight. With careful sampling directly over a hail hit, bitumen can be removed from the felt by solvent extraction to permit microscopic examination of reinforcement. Figure 12 depicts magnification of fibrous glass in the immediate region of minor impact. Glass fibers are actually hollow, as can be seen at this level of magnification; note that individual filaments were not ruptured from this particular hail event.

*Figure 12 – Magnification of fibrous glass in the immediate region of minor impact. Individual filaments were not ruptured from this particular hail event.*

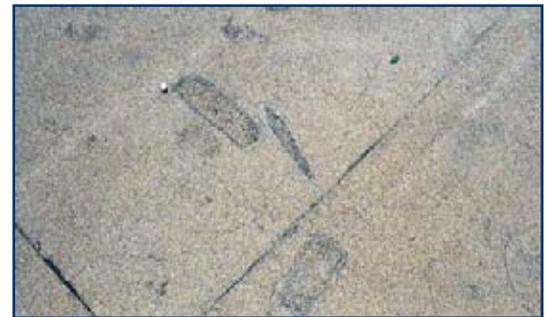
The granule-surfaced modified bitumen depicted in Figure 13 was on a major upscale facility of notoriety and was the focus of a recent dispute. The surface markings shown were claimed as hail compromise when, in fact, they are the attempts after installation to rework scarred regions with a torch and additional granules (for

*Figure 13 – Granule-surfaced modified bitumen has been reworked with a hot trowel and loose granules for cosmetic purposes. The markings are not from hail.*

cosmetic purposes). Hailstorms do not produce rectangular or linear pockmarks, even with highly angular approach directions. Some theories about hail damage, enthusiastically communicated to this writer, seem impervious to contamination with fact.

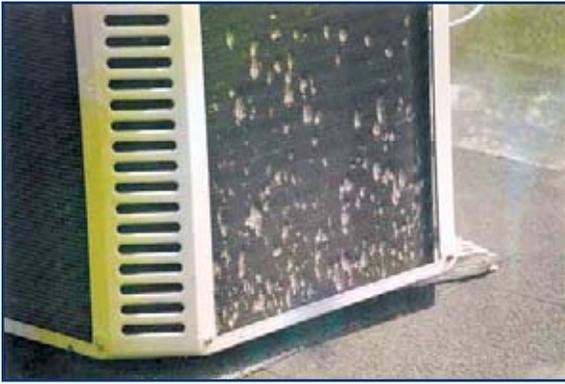
Deformed cooling fins on HVAC units are the sure signature of hail exposure (Figure 14). The condition can be moderate, corrected by a tradesman “combing” the fins; it can also be severe, rendering such attempts futile.

Figure 14 – Deformed cooling fins on HVAC units are the sure signature of hail exposure.

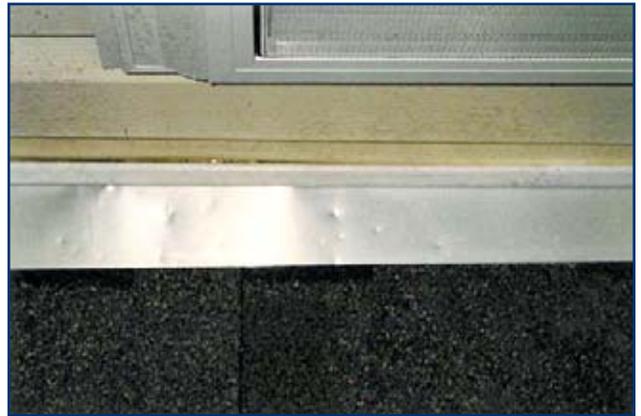
Examination of accessory metals such as gutters or light-gauge flashings (Figure 15) can also be helpful in evaluating the severity of hail exposure. Particle diameter can often be estimated, and directional ori-

Figure 15 – Light-gauge metal flashings can be helpful in evaluating the severity of hail exposure.

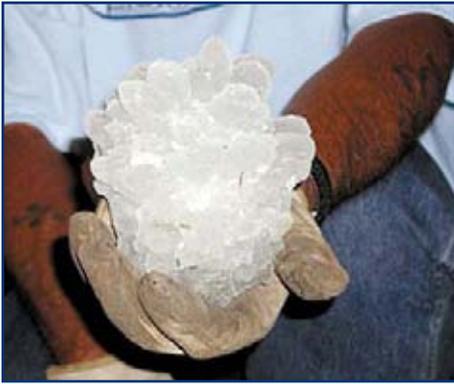
spikes, likely caused by spinning while aloft (Figure 16).

Figure 16 – Large, highly angular, spiked hailstone (image from [www.ucar.edu/research/storms/hail.shtml](http://www.ucar.edu/research/storms/hail.shtml)).
