EPDM Roof System Performance:

An Update of Historical Warranty Service Costs

By James L. Hoff

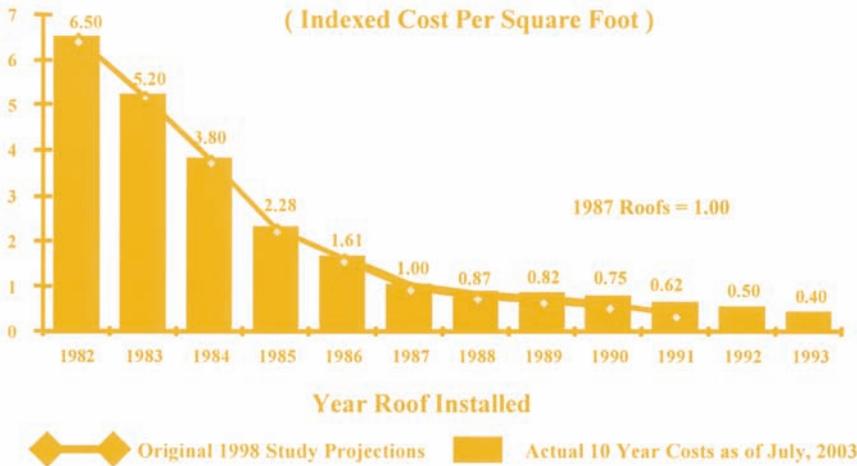
Chart 1
EPDM Warranty Service Costs:
First Ten Years of Service
 (Indexed Cost Per Square Foot)

At least ten years of actual historical warranty service costs are now available for all roofs installed in 1993 or earlier. *Chart 1* illustrates the overall change in warranty service spending during the first ten years of service for EPDM roofs installed each year from 1982 to 1993. As illustrated by the chart, unit warranty service costs declined 85% from 1982 to 1987. As will be discussed later in this paper, the significant drop in costs is most likely attributable to changes in product technology introduced during those years. Although the improvement trend begins to flatten out slightly from 1987 through 1993, cost reductions continue each year, and even these smaller incremental improvements account for another 60% reduction in warranty service cost.

It should be noted that when this study was first published in 1998, complete historical data were available only for the first five years of service for many of these roofs. As a consequence, the ten-year warranty service costs were estimated by applying regression analysis to the five-year trends available at that time. Five years later, it is very gratifying to report that the actual ten-year trends indeed follow the 1998 prediction. In order to demonstrate the closeness between the 1998 projections and actual results today, a line indicating the original projection has been added to *Chart 1*. It should be noted that any slight differences in the projected and actual cost are statistically insignificant at a 99.5% level of reliability.

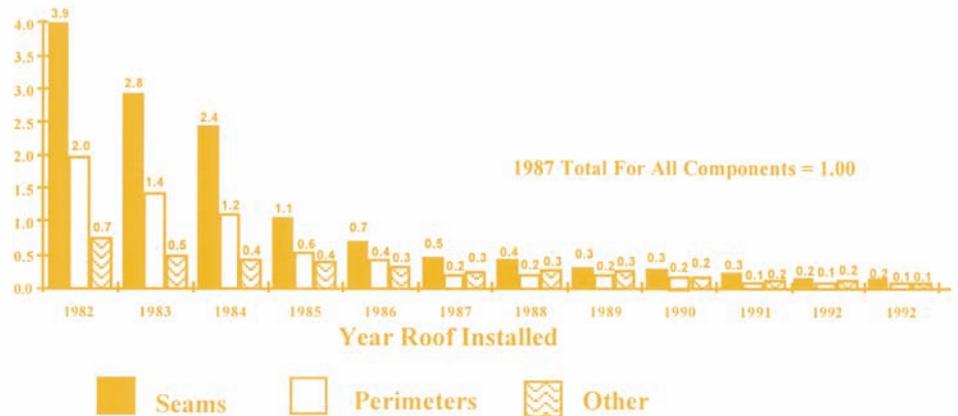
Chart 2
EPDM Warranty Service Costs by Key Component
 (First Ten Years of Service / Indexed Cost Per Square Foot)

Chart 2 provides a breakdown of ten-year costs by the type of component

requiring warranty service. For this study, components were divided into three broad categories: 1) field seams; 2) perimeter flashings, such as base tie-ins, edge metal flashings, and terminations; and 3) other components, including curbs, penetrations, and membrane attachment. During the period from 1982 to 1993, warranty service costs for both field seams and perimeter flashings improved significantly. The trends in this chart appear to reinforce the commonly held opinion that much of the improvement in EPDM system performance is due to changes in seaming and attachment technology. Costs associated with field seams and perimeter flashings have declined 92% and 95%, respectively. It should be noted that this improvement coincides with the introduction of several important component technologies by the roofing manufacturer:

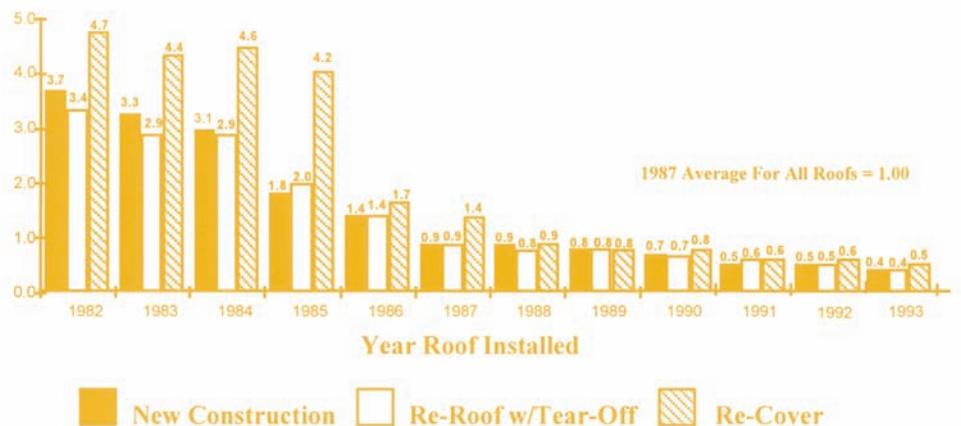
Chart 4
EPDM Warranty Service Costs: New / Re-Roof / Re-Cover
(First Ten Years of Service / Indexed Cost Per Square Foot)

Chart 5 shows the ten-year performance trend for two approaches to roof replacement: 1) re-roof, or the tear-off of the existing roof and installation of a new roof, and 2) recover, or the installation of a new roof directly over the existing roof. For comparison purposes, the chart also provides similar information for roofs incorporated into new construction work. Although the ten-year warranty service costs for new construction and re-roofing projects installed during the early 1980s were almost equal, the costs of recover projects in the early 1980s were significantly higher than either new construction or re-roof warranty service costs. However, this difference in costs narrows each year. By

1988, the gap in warranty service cost between recover and re-roofing has virtually disappeared. In fact, for roofs installed between 1988 and 1993, the difference in ten-year repair costs between EPDM recover and re-roofing is statistically insignificant.
