Denver International Airport Is Reroofed with EPDM after a Hailstorm

JULY 27, 2016 BY LOUISA HART LEAVE A COMMENT

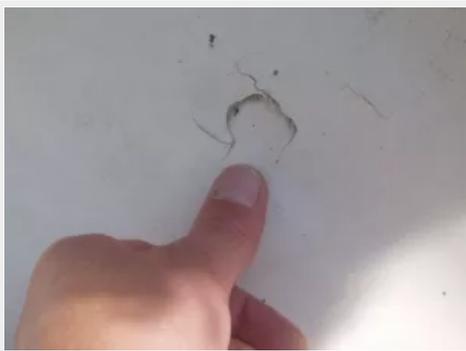
The storm created concentric cracks at the point of hail impacts and, in most cases, the cracks ran completely through the original membrane.

Lovato’s inspection of the hail damage revealed the extent of the problems with the airport roof. The original PVC membrane, installed in 1991, was showing signs of degradation and premature plasticizer loss prior to being pummeled by the June 2001 storm. The storm itself created concentric cracks at the point of hail impacts and, in most cases, the cracks ran completely through the membrane. In some instances, new cracks developed in the membranes that were not initially visible following the storm. The visible cracks were repaired immediately with EPDM primer and EPDM flashing tape until more extensive repairs could begin. Lovato notes that while nature caused the damage to DIA, nature was on the roofing team’s side when the repairs were being made: The reroofing project was performed during a drought, the driest in 50 years, minimizing worries about leaks into the terminal below and giving the construction teams almost endless sunny days to finish their job.

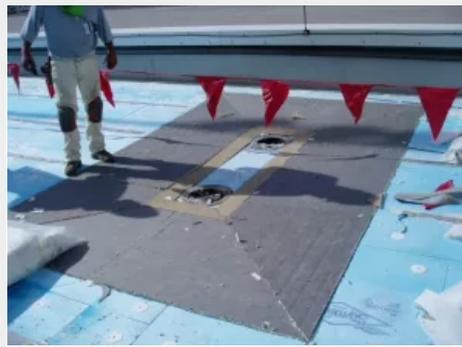
The initial examination of the roof also revealed that the existing polystyrene rigid insulation, ranging in thickness from 4 to 14 inches, was salvageable, representing significant savings.

The initial examination of the roof also revealed that the existing polystyrene rigid insulation, ranging in thickness from 4 to 14 inches, was salvageable, representing significant savings. Although a single-ply, ballasted roof was considered and would have been an excellent choice in other locations, it was ruled out at the airport given that the original structure was not designed for the additional weight and substantial remediation at the roof edge perimeter possibly would have been required.

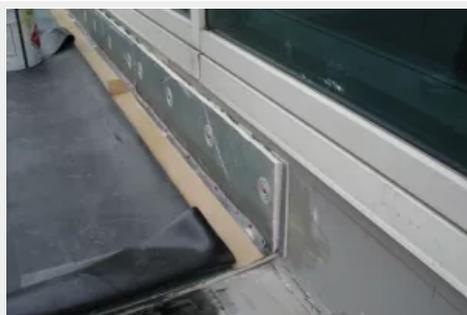
In some areas adjacent to the airport's clerestory windows, the membrane received much more solar radiation than other areas of the roof.

In some areas adjacent to the airport's clerestory windows, the membrane received much more solar radiation than other areas of the roof. When ambient temperatures exceeded 100 F, some melting of the polystyrene rigid insulation occurred. "That section of the roof was getting double reflection," Lovato points out. To reduce the impact of this reflection, the roof was covered with a high-albedo white coating, which prevented any further damage to the top layer of the polystyrene rigid insulation board and also met the aesthetic
