New Roof
System
Addressed
Challenge

at Clarksville
University
Athletic P

CLARKSON UNIVERSITY INDOOR ATHLETIC CENTER POTSDAM, NEW YORK

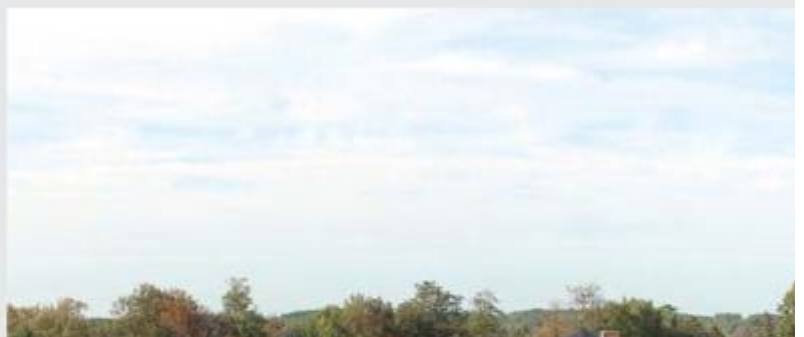
The roof system included two layers of 2.6-inch polyiso insulation and a half-inch layer of cover board.

The first step in this installation was tearing off the existing roofing membrane and installing new perimeter wood blocking around the existing wood deck. The crew then installed a vapor barrier directly to the wood deck, followed by mechanically installing two layers of 2.6-inch polyiso insulation, and a half-inch layer of cover board.

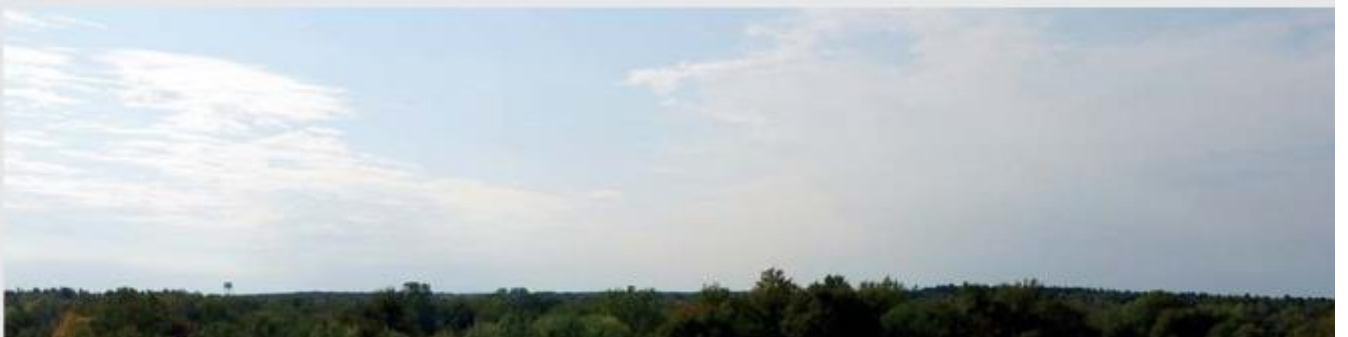
Crews from RSI Roofing are installing approximately 66,300 sq ft of EPDM membrane on the roof.
