# **TECHNICAL BULLETIN**

## **No.2023-2**

### **Case Study - Cool Roof Effects on Sheathing and Framing**

From: WSRCA Low-Slope Roofing Committee

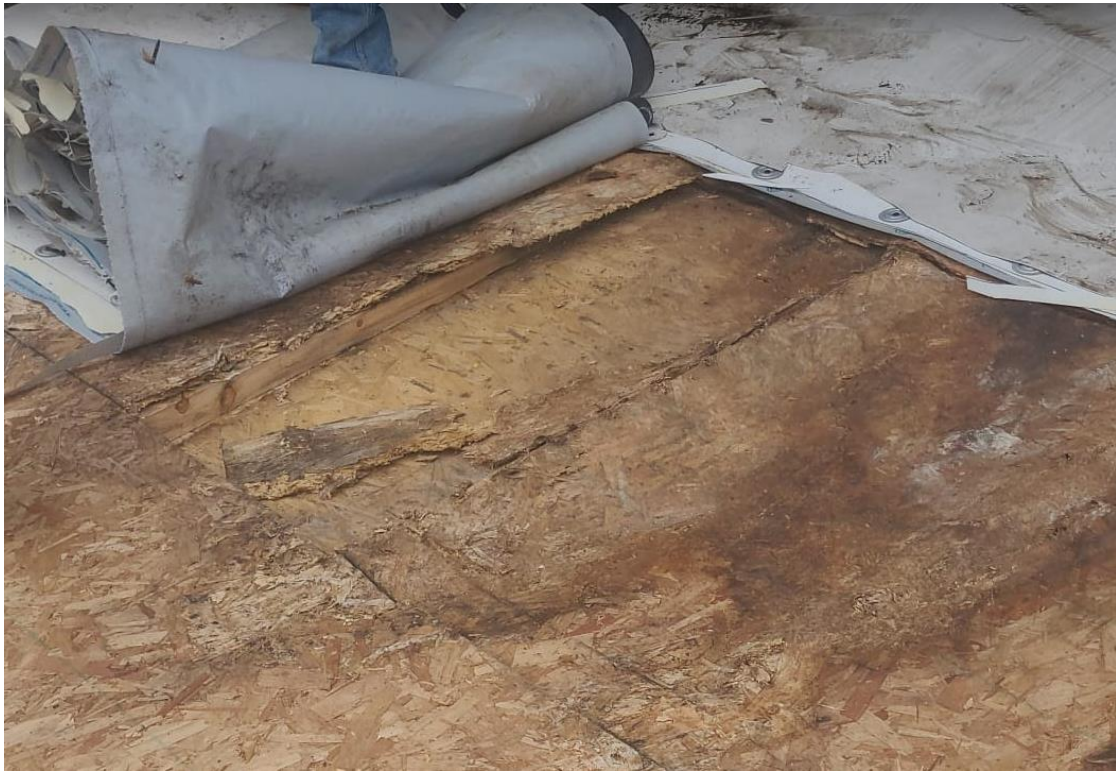
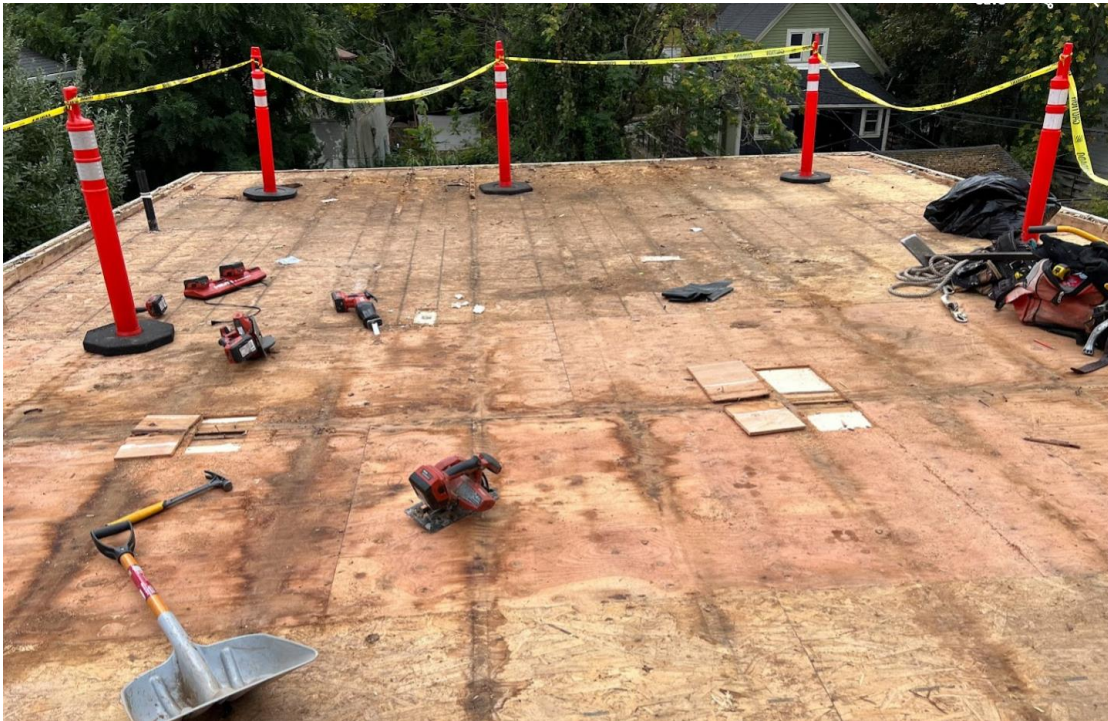
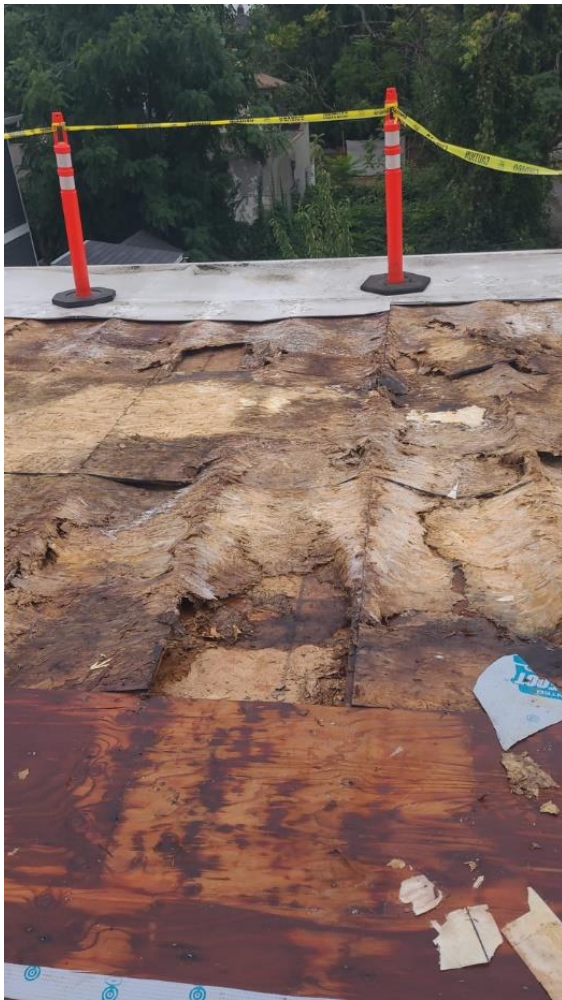
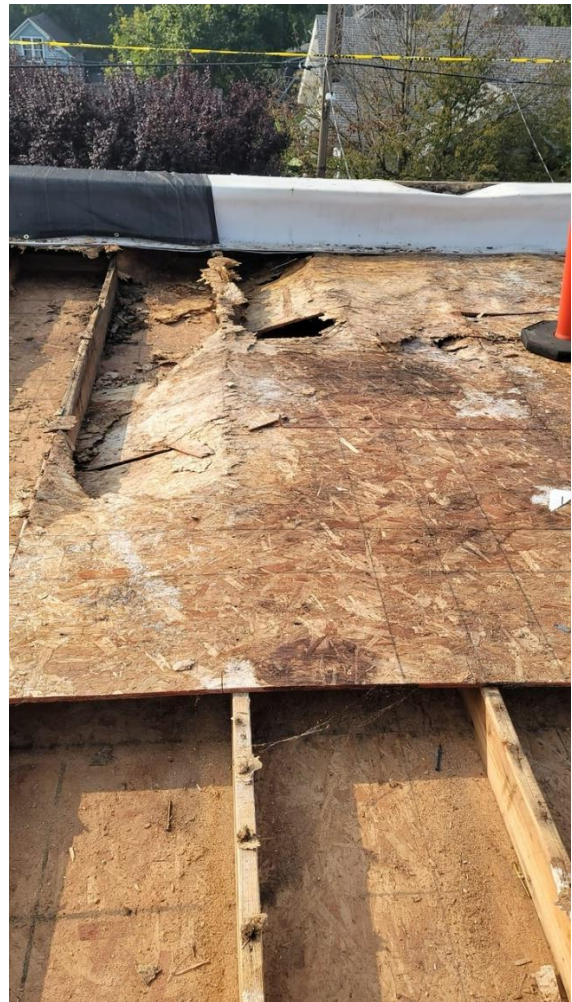
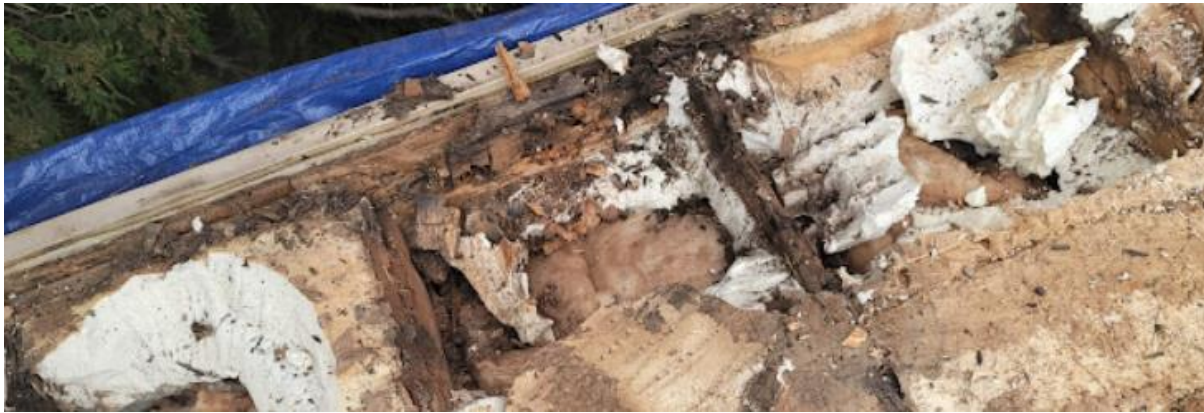
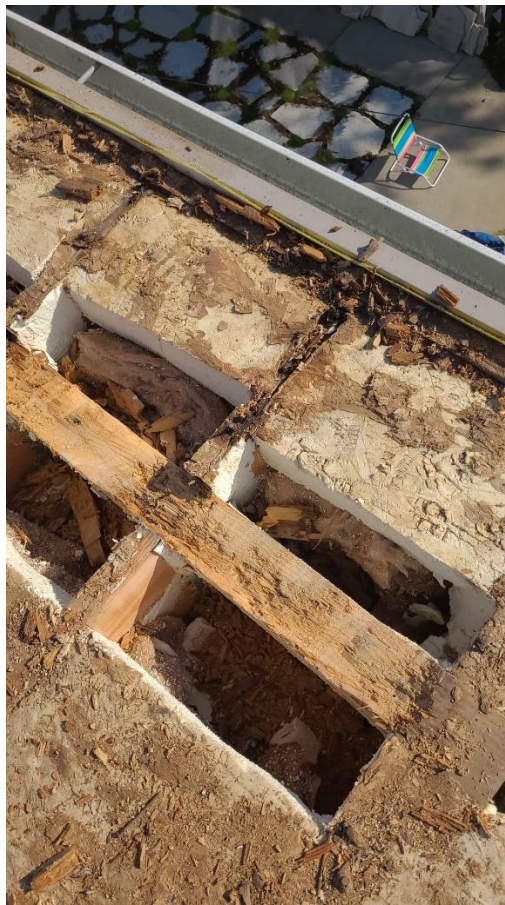
The photographs below show the as-built conditions and the extensive damage that was revealed when the roof covering was removed.

Within five years, the underlying OSB sheathing had deteriorated. Apparently, the closed cell spray foam insulation either did not bond to the adjacent rafters and/or was not installed continuously

to create a functioning vapor barrier. Possibly there was excessive moisture when the roof was installed and closed in the cavity. The absence of a functioning vapor barrier and venting allowed interior moisture-laden air to reach the unfilled cavities and create high relative humidity. Condensation occurred on cold days and nights, and even during relatively warmer nights, due to radiative cooling of the roof membrane. We also noticed that sections covered with plywood were intact and not as deteriorated as the OSB sheathing, despite being wet from condensation. The attached photographs illustrate how the combination of wet sheathing and highly reflective roof membranes can adversely affect the performance of the sheathing and wood framing.

The repair for this roof required extensive framing and sheathing replacement and a new roof system above the plywood diaphragm that included a vapor retarder, 2 staggered layers of 2" polyisocyanurate insulation, a tapered polyisocyanurate insulation to provide a 1/4" per ft slope, 1/2" high density polyisocyanurate cover board, and mechanically fastened thermoplastic single ply

membrane. This roof assembly will achieve an r-27 average r-value and prevents interior moisture-laden air from reaching the dew point temperature and causing condensation.
