# Evaluating Ballasted Single-ply Roof Systems

RP-4 stone ballast stays put during Florida hurricanes

BY MICHAEL RUSSO / **RSI** Associate Publisher & Editor

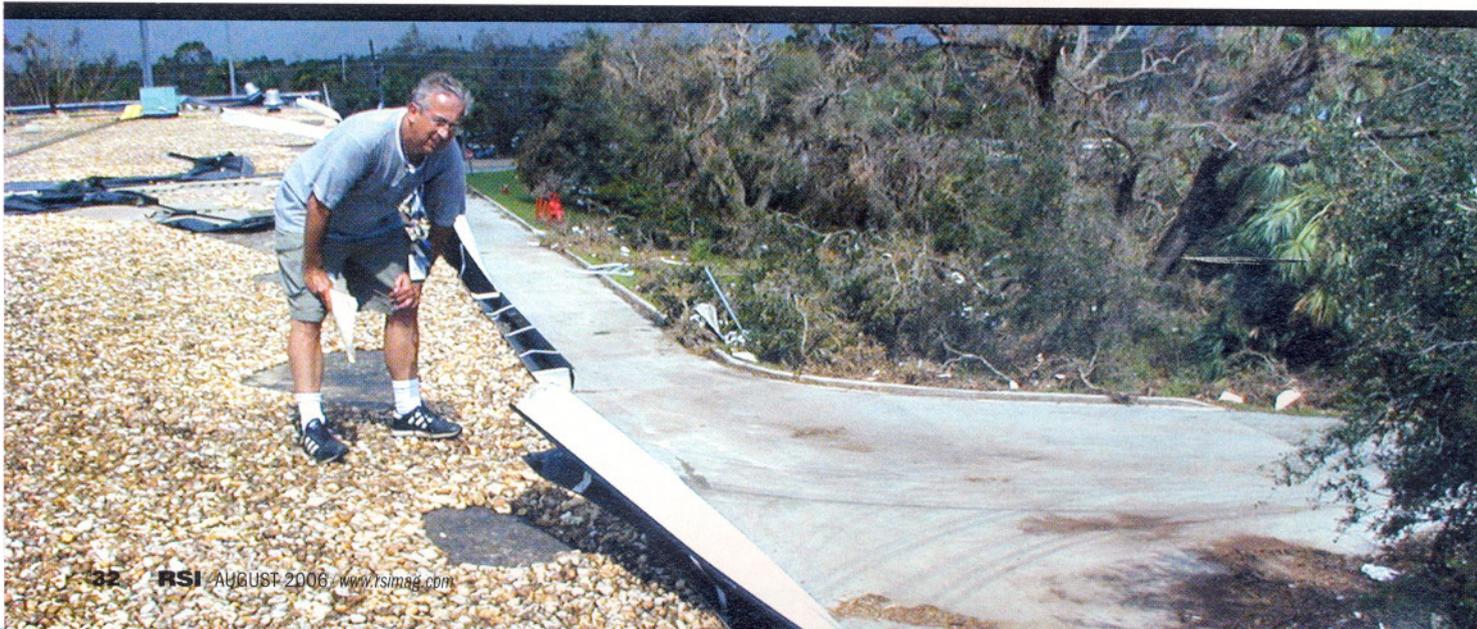
*This large retail building in Punta Gorda, Fla., with a ballasted, loose-laid, unreinforced EPDM membrane, experienced wind speeds in excess of 140 mph during Hurricane Charley. Even without a gravel stop, ballast remained in place in some locations along the south perimeter. (Photos courtesy of RICOWI Inc.)*

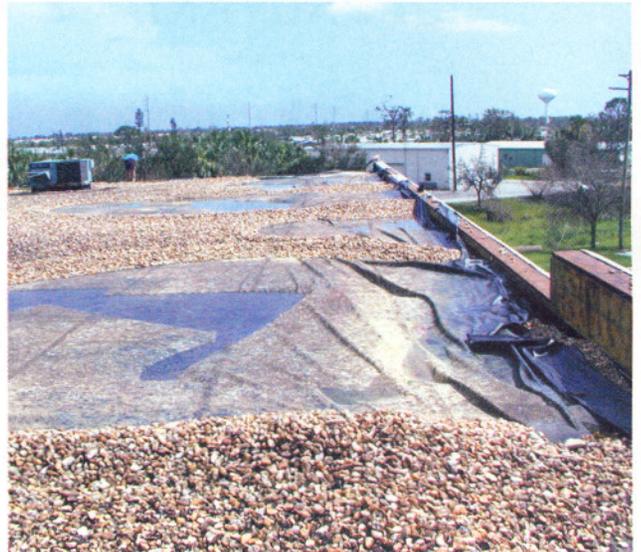
This ballasted retail building roof experienced ballast and membrane displacement, but the parapet wall kept the stones on the roof.

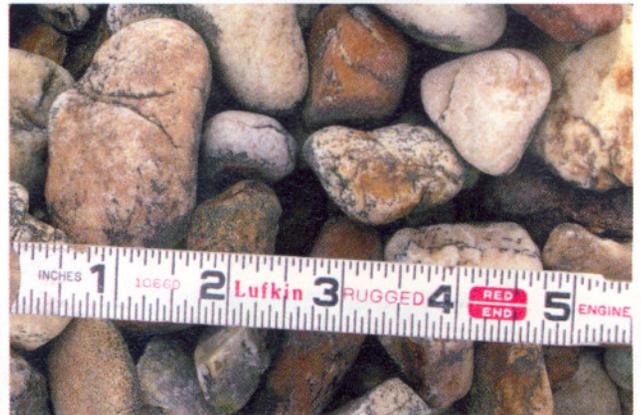
Code officials concerned about stone ballast size can have stone screened according to ASTM D 448. However, a relatively quick measure of stone size can be accomplished by laying a ruler on the stone and determining average size by eye.

Gravel scour in right hand corner of ballasted roof after Hurricane Ivan. See the photo above for a close-up of the stone size used for this application.
