“Cool” Roofs Cause Condensation – Fact or Fiction?

by Phil Dregger, PE, RRC, Technical Roof Services, Inc.

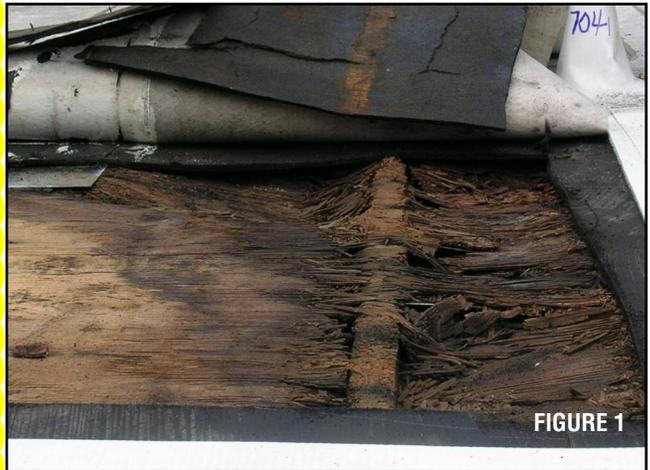
Figure 1 shows severely deteriorated plywood discovered a few years after replacing an old cap-sheet built-up roof (BUR) with a white single-ply roof in the San Francisco Bay Area. Workers sent to investigate reports of the roof “dripping” found no obvious openings for “roof leaks” but found many “soft spots.” Before the white single-ply roof was installed, the old BUR had been in place for many years without similar reports of dripping or “soft spots.” Changing from a non-cool roof to a highly reflective “cool” roof is believed to have at least contributed to these problems.

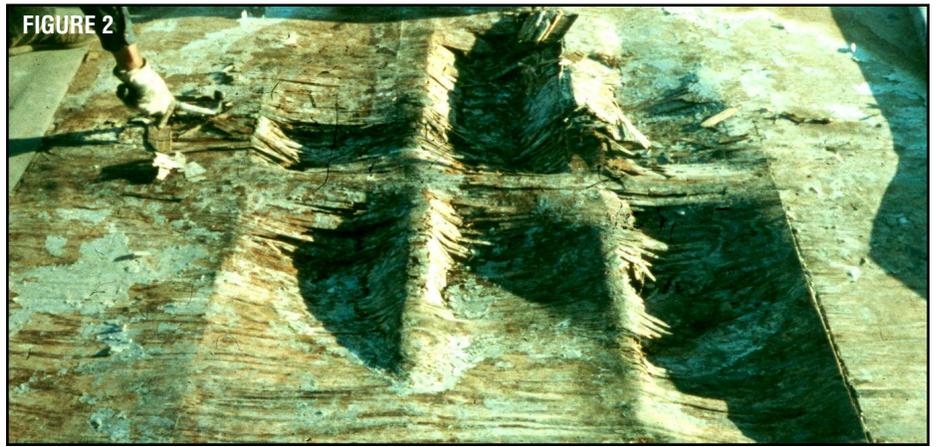
Figure 2 shows severe deterioration caused by water vapor migrating up through the ceiling of a laundry room (with insulated rafter spaces) and condensing on the "cold" under-

side of the roof membrane and plywood roof deck. Eventually, the plywood got wet enough, warm enough, and for long enough to support the growth of wood decay fungi.

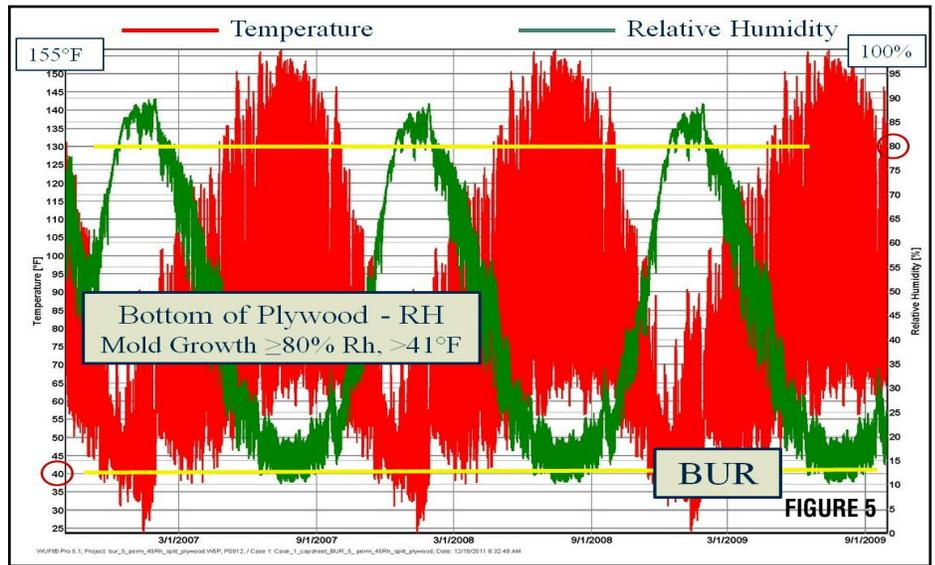
Figure 5 indicates WUFI predicted fluctuations in temperature and relative humidity (a measure of the water present) near the bottom surface of the plywood roof deck with the original built-up roof. Figure 6 indicates WUFI predicted fluctuations in temperature and relative humidity after installation of the highly-reflective overlay. Superimposed on both figures are yellow lines representing 80% relative humidity (RH) and 41°F.

The WUFI graphs indicate that after installation of the reflective overlay the plywood did not get as hot (e.g., maximums near 115°F rather than 155°F) and accumulated more water (higher RH), and held it longer, than it did previously. Is this predicted difference important? According to a new ANSI/ASHRAE Standard, yes, it could make a significant difference.

ANSI/ASHRAE Standard 160-2009 “Criteria for Moisture-Control Design Analysis in Buildings” recommends specific performance criteria to “minimize the undesirable effects of moisture in a building or building envelope.” Among other things, the standard recommends roof and wall systems be designed to limit how high the RH of materials like wood get and for how long. One criterion is that the “30-day running average surface RH <80% when the 30-day running average surface temperature is between 41°F and 104°F.” Again, the yellow lines in Figures 5 and 6 represent 80% RH and 41°F temperature.

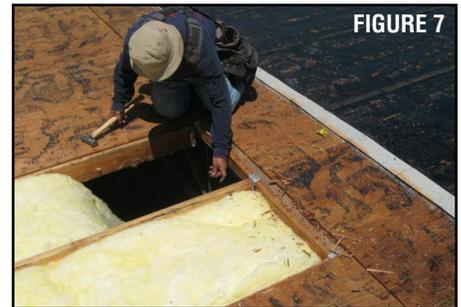
FIGURE 7

Figures 7 and 8 show roof construction along truss purlins where modest gaps in the foil-faced batt insulation allowed interior air to

enter, condense, and accumulate on the wood deck during cold weather. In the spring, with higher temperatures and plenty of water to work with, very high vapor pressures were created at wood deck level, forcing water vapor downward where it condensed on nearby metal surfaces and dripped out.
